Improving the Capability for Real Time Assessment of Roof Conditions Through Intelligent Roof Bolt Drilling Operations

Robert Anderson, Design Engineer
J. H. Fletcher & Company
Huntington, WV

L. J. Prosser, Research Scientist
NIOSH-Pittsburgh Research Laboratory
Pittsburgh, PA

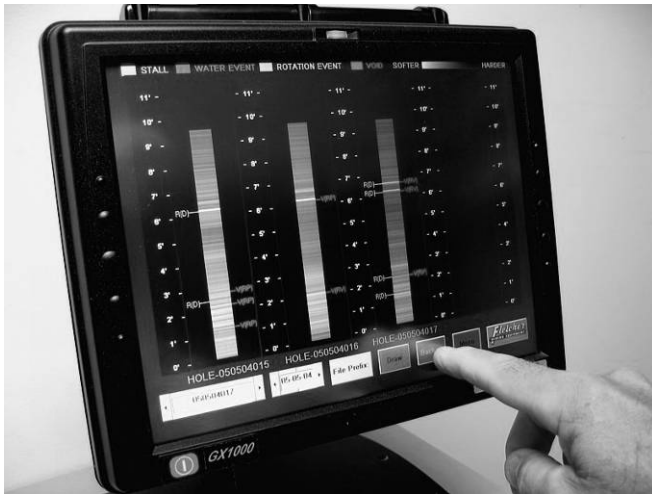
The software was tested in the laboratory and in the mine and was refined to improve its accuracy. In a recent project with West Virginia University (WVU), the software was modified to communicate in real time with the drill control unit and display the information as the holes were being drilled. With this new system, graphs illustrating information from four separate drill holes were displayed side-by-side so that trends could be easily seen. The display and analysis can be activated through a rugged touch screen panel installed on the bolting machine to facilitate use underground by the roof bolter or other mine officials (see figure 2).

Figure 2. FLETCHER® Information Display

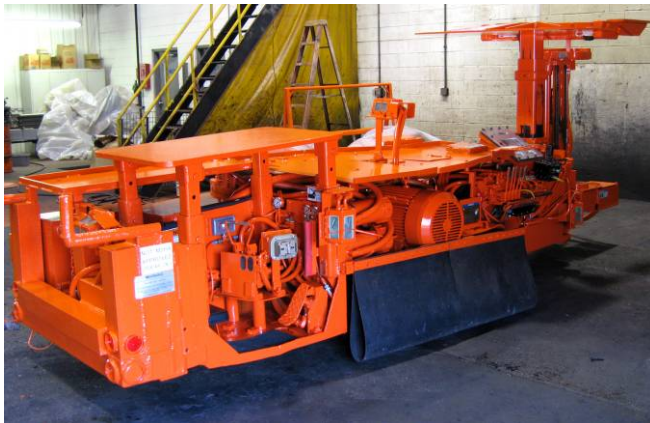
In another joint project with WVU, a test machine was built for use in an underground coal mine. An older single-boom roof bolter was rebuilt with modern components including the latest generation of drill head and drill control unit. The FLETCHER® Information Display was installed in an explosion-proof housing on the machine. Figures 3 and 4 show the coal test machine and the information display.

Figure 3. Roof bolter used for testing in underground coal mine.

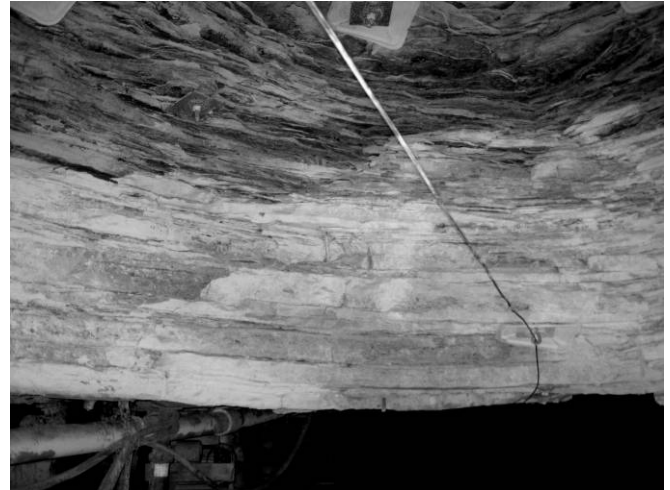
The test machine was moved to another section of the mine where there had previously been roof problems including a large roof fall. Figure 5 shows this area and gives a cross section of the roof strata in this area.

Figure 5. Section of roof adjacent to large roof fall.

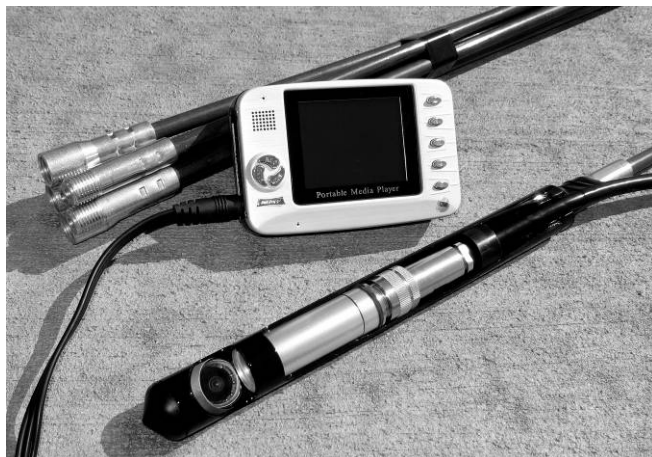
Scoping holes were also analyzed using a small bore scope (less than 1 in diameter) as shown in figure 7. Video files were recorded for each hole. Initially, the bore-scope videos showed few discontinuities in the holes. Only two of the holes had obvious voids (see figure 8). The holes were flushed out with water, assuming that dust from the drilling might be obscuring the voids. The holes were bore-scoped a second time and again there were not clear voids at the locations indicated on the drill data files. A scratch tool was used to feel for soft bands or ledges in the holes.

Figure 7. FLETCHER® Bore Scope.

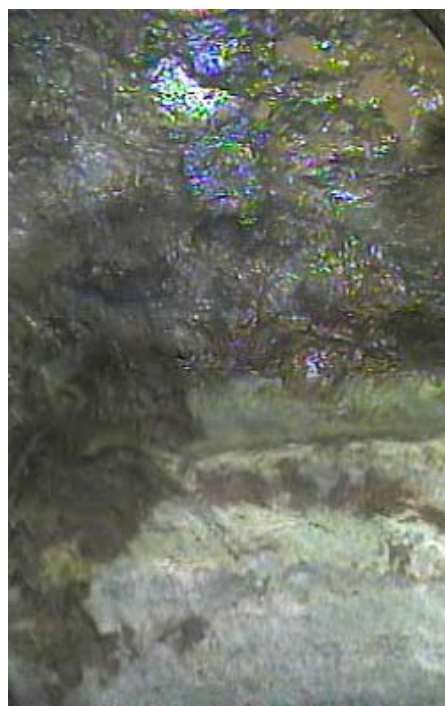
A Pennsylvania limestone mine which has the pendant recorder on a roof bolter offered another opportunity to record drill data files and compare them to bore-scope video. Again, NIOSH was present to observe these tests. Here, four holes were drilled in two different sections of the mine. Three of the holes showed large clay seams near the top of the hole. These were visible in the drill data files as lighter shades of gray. When the software sensitivity was adjusted they were marked as voids. The clay seams were clearly visible in the bore-scope videos. Figures 14 and 15 show the hole graphs and a bore-scope image.

Figure 15. Bore-scope image of clay seam.

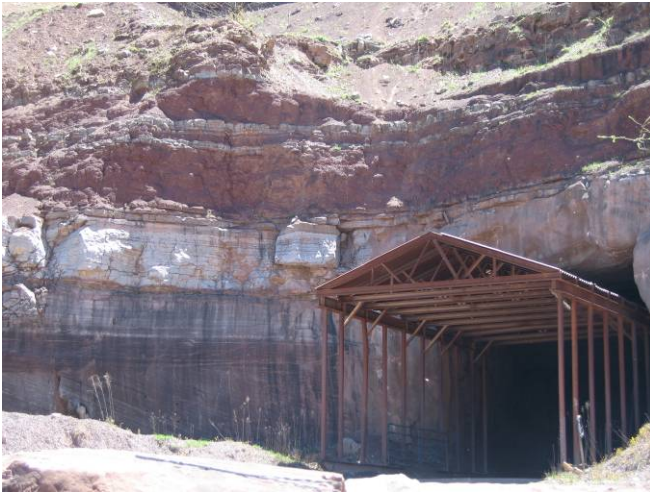
A photo from outside the mine opening shows the red clay above the limestone seam (see figure 16).

Figure 16. Red clay above limestone.
